CASE STUDY

VESSEL TYPE: Harbour Craft
TRADING AREA: Europe and Middle East

HEADING : Size does matter

Case No. 44485

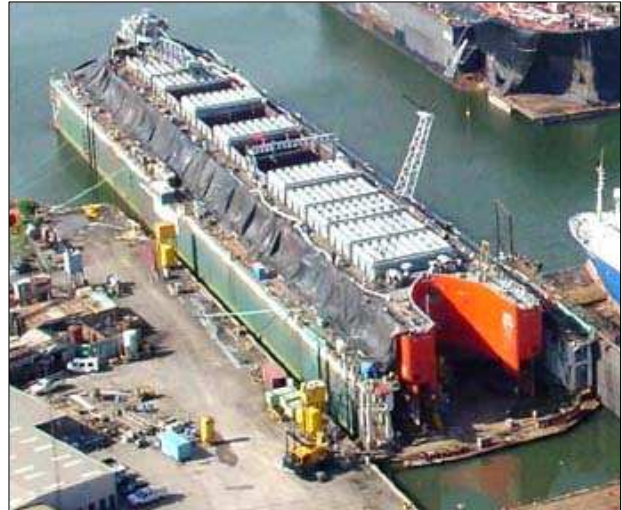
The operation required the dock to be manoeuvred across the port approach channel, down which a supply vessel was navigating. In order to give this vessel more sea room, the tugs towing the dock eased off. The dock then started to drift towards vessels moored at a nearby berth and despite the best efforts of the tugs, the dock continued towards the moored vessels, eventually making contact with one.

Two factors played a part in the cause of this incident. The bollard pull of the tugs was considered insufficient for the size of the dock. A strong current was flowing at the time of the operation and the tugs were not of sufficient power to regain control. Secondly, neither the dry dock operations department nor the tug masters took it upon themselves to inform the port control of the operation. Had this been done, the manoeuvre would have probably been delayed until the channel was clear or the inbound vessel prevented from entering the channel.

All in all the operation was very poorly planned.
