## CASE STUDY

**VESSEL TYPE:** DRY CARGO  
**TRADING AREA:** ASIA  
**HEADING:** A Cover Up

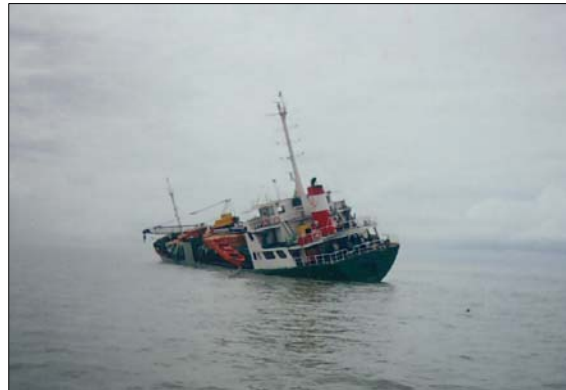
Shortly after sailing from port a slight list was noted and following a substantial alteration of course the vessel listed further. As the evening progressed the list increased to over 40 degrees at which point the Master ordered the crew to abandon ship. Upon being rescued, a number of the crew re-boarded the vessel once a tug was in attendance. The vessel was subsequently anchored and her cargo was discharged into barges.

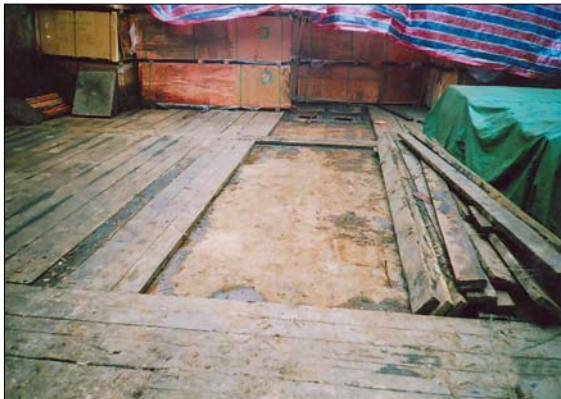
Upon completion of the discharge it was found that the hold contained approximately 30 cm of free water. The tank top was covered by wooden sheathing and, once this had been removed, it became clear the tank top was holed in a number of places. These penetrations into the double tank had allowed ballast water to enter the hold.

The events during the early part of the voyage suggest the cause of listing was in all likelihood due to insufficient stability compounded by free water in the hold, although the extent of the free surface effect was reduced as the vessel was loaded. Unfortunately stability records were not

available. The tank top had suffered severe corrosion which had been masked by the permanent wooden deck sheathing. This case emphasises the need to ensure that tank tops are examined at regular intervals. Sections of the protective cladding must be removed at this time to facilitate a thorough examination.

We cannot over emphasise the need for the close monitoring of the vessel's stability at all stages of a voyage and the need to retain all relevant calculations.
