▶ IMPROPER SECURING ARRANGEMENT OF SEA STRAINER COVER LEADS TO VESSEL CAPSIZING

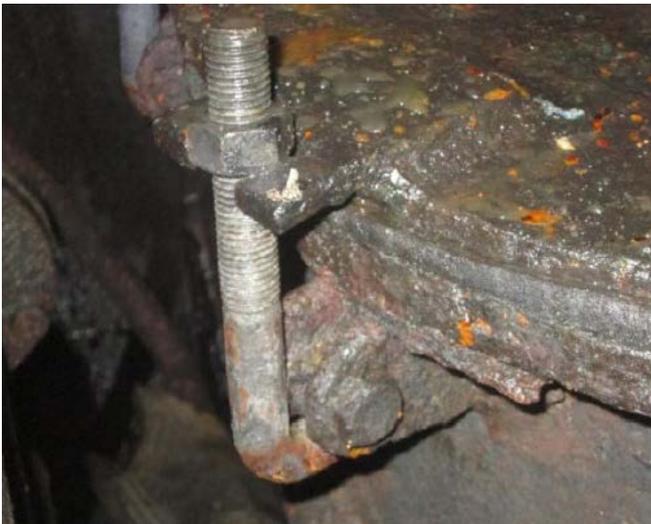
A salvage operation was completed, and upon investigation, the point of water ingress was identified as a loose port side sea strainer cover.

On the port side sea strainer, only one of the eight wing nuts was found to be in place and standard nuts had been used on the other seven bolts, therefore the securing arrangement had lost most of its integrity. The bolts were also found to be rusty and general condition of the sea strainer was poor.

Completion of tasks such as securing of the sea strainer covers should be suitably supervised by a competent person as required by company procedures and the relevant task risk assessment.

Replacement spares used on critical equipment should be as-per their original design to ensure fitness for purpose.
