The Shipowners' Protection Limited
St Clare House
30-33 Minories
London
EC3N 1BP

Published April 2008

Gangways

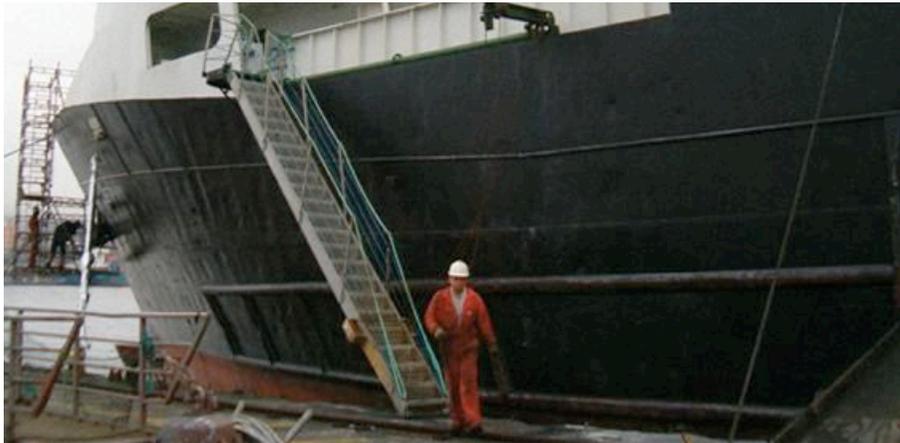
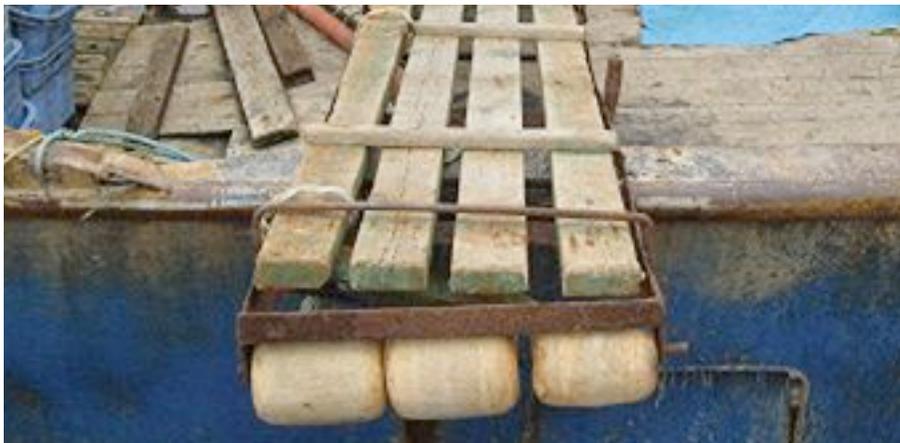
Figures 2 and 3: Means of access incorrectly rigged

- 5 Safety Net – If it is applicable and practicable a safety net is to be fitted under every part of the access ladder or gangway extending on both sides and kept taut. The net must not be secured to any fixed point on the quay. Figures 2 and 3 show gangways incorrectly rigged therefore increasing the risk of incidents. Figure 4 shows a correctly rigged gangway, with access ladder, security point, security notices and the permanent presence of a watch keeper.

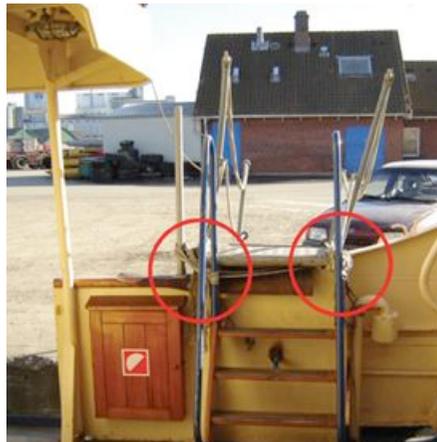
7 Bulwark Ladder – These should be utilised when the top of the gangway or portable ladder rests or is level with the bulwark. It should be securely attached to the vessel to prevent movement and must be equipped with 2 rigidly secured handrails / stanchions. Figure 5 shows a bulwark ladder in use but as highlighted is incorrectly secured to the vessel by using its goose neck vent.

Figure 5: Gangway incorrectly secured to the vessel

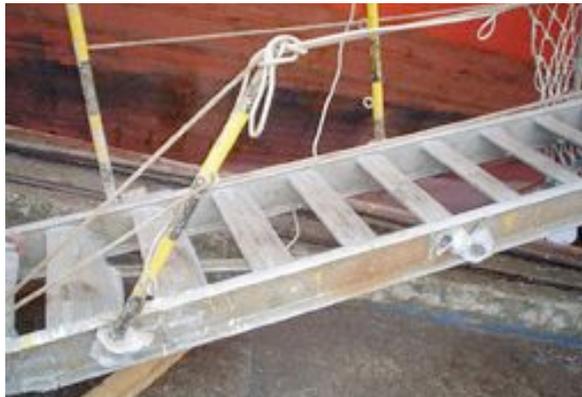
Figure 8: Gangway in need of maintenance

- Cleanliness
- Faults, including physical damage. All boarding equipment should be maintained and checked at regular intervals designated by a planned maintenance programme. Any faults which are noted on the equipment must be dealt with immediately and in a fully approved manner. Aluminium equipment should be particularly checked for corrosion and ladders should not be painted in case this conceals defects
- All moving parts are in good working order and are well greased
- All associated equipment is available and correctly located

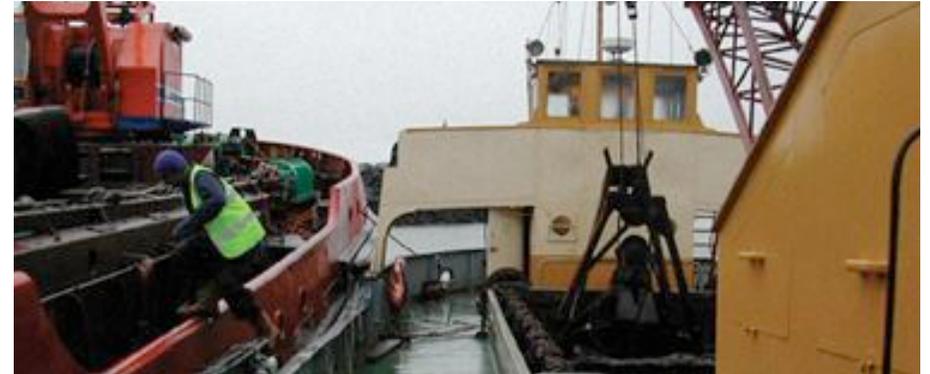
Figure 9: A crew member leaping from one vessel to another as no correct means of access is rigged

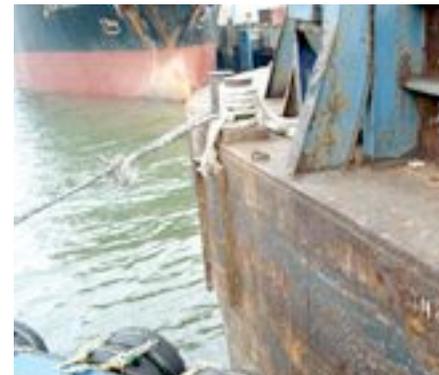
Figure 10: Incorrect access between two vessels

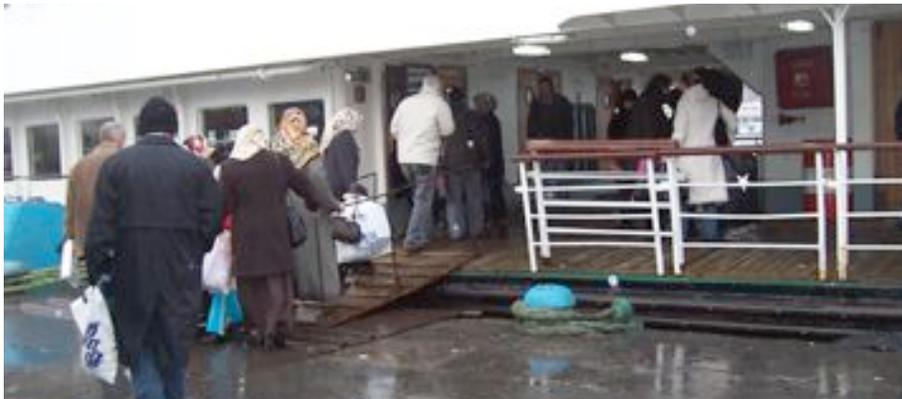
Prior to the commencement of embarking / disembarking operations it is important for the crew members concerned to assess the boarding area for any potential problems e.g. the requirement to rope off unguarded areas around gangway as shown in Figure 14 (this highlights an unprotected area existing between the gangway and vessel's railings that should be roped off accordingly).

Figure 14: The area between the gangway and vessel's railing left unguarded

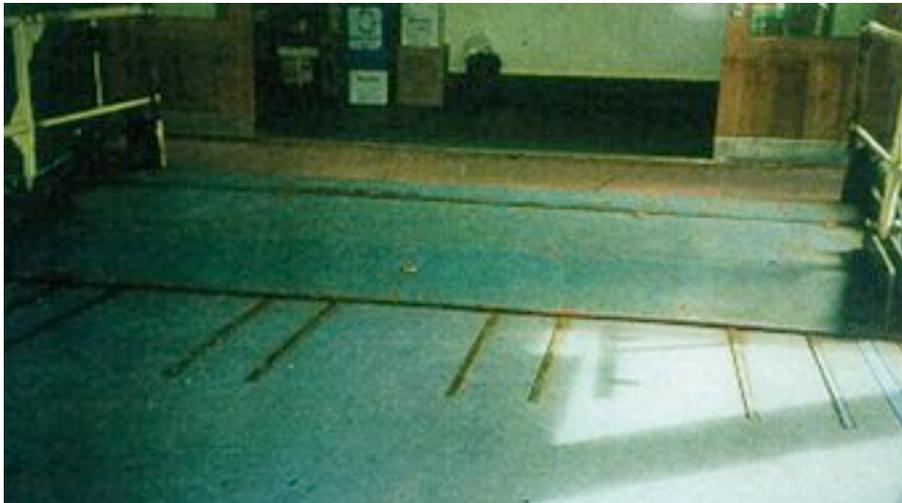
This incident arose on board a harbour ferry operating in smooth water. The harbour ferry was fitted with hydraulic ramps designed for the embarkation or disembarkation of passengers. The ramps had been lowered to enable passengers to board the vessel and having been positioned hydraulics were 'locked'. Shortly after passengers started to board another vessel backed into an adjacent wharf creating some wash. The combination of that wash and wave actions in the harbour caused the ferry to surge and roll. The movement resulted in the hydraulic ramp fitted to the ferry rising a few inches up off the connecting hydraulic ramp fitted to the jetty. When the vessel rolled back a passenger's foot was trapped between the ramps.

Surprisingly the claimant's lawyers did not argue that the ramp was unsafe because it did not hinge. Instead they concentrated on the fact that the wharfhand on duty had been

preoccupied with tying up another vessel when the accident occurred and that the ramp was unattended. Plaintiff's lawyers alleged that had the crewman been at his place of duty he could have warned passengers of the danger and prevented them from boarding until it was safe to do so.

As per Case Study 2 (see appendix) some claims occur when people get their feet caught under the wheels or roller at the end of the gangway as the vessel surges. This can be prevented by fitting a metal plate onto the end of the gangway. This will push the person's feet away as the vessel surges without restricting the movement of the rollers/wheels.
