SHIPOWNERS
SECURITY FOR SMALL & SPECIALIST VESSELS

▶ CASE STUDY

FALL INTO CARGO HOLD RESULTS IN FATALITY

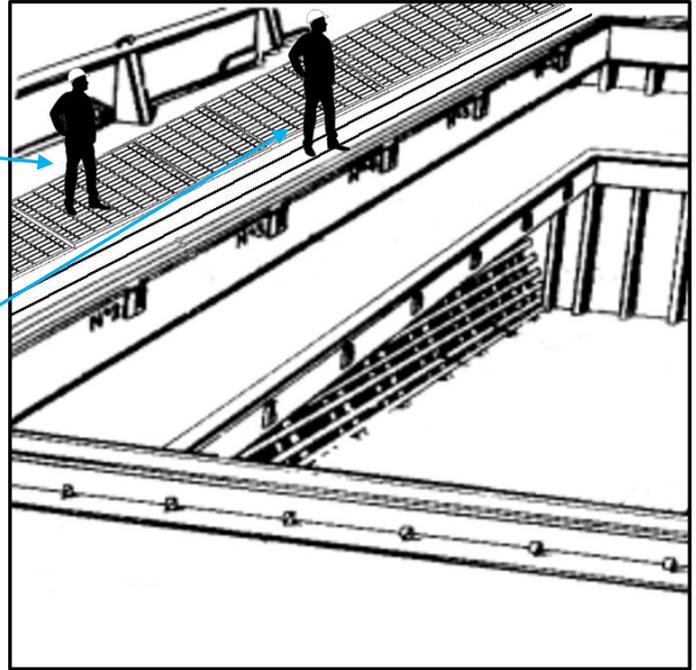
- The decks were all reported to be dry at the prevailing time.
- There were no safety rails, nets or stanchions rigged around the cargo hold.
- There was a platform/passageway around the cargo hold that was supposed to be used to observe the cargo operations in the hold. Unfortunately, the crew member stationed himself on the hatch coaming to oversee the loading operation. In this location there were no preventative measures in place to stop him from falling into the hold.

Normal signalling position on platform

Position at the time of incident on coaming

- 1. Marking of observation areas/signalling areas:** Dedicated observation/signalling areas should be clearly marked and highlighted. These areas should be positioned so that supervision of the prevailing operation, including actions such as signalling to the crane operator can be carried out safely whilst also maintaining a safe distance from the edges of the cargo hold away from any slip/trip hazards.

- 2. Placing removable stanchions with guard ropes:** Hatch coamings of most vessels are designed to allow safety stanchions to be inserted. This enables a safety rope/chain to be installed around the open hatch to assist in preventing accidental falls into the hold. Where such an arrangement exists, crew must be adequately briefed to ensure that these are always put in place as soon as the hatch covers are opened. On vessels where such arrangements do not exist per design, a suitable risk assessment should be carried out to install a temporary safety rail to guard the open hatch coaming. If this risk is identified, consideration should be given for the fabrication of a safety rail system.
