Guidance On Ensuring The Weathertight Integrity of Hatch Covers

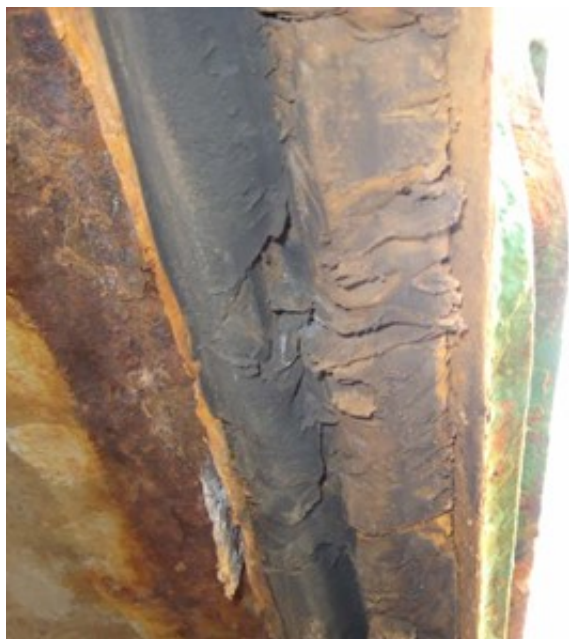
Figure 5: Hardened indented rubber seals

Hatch cover rubber seals need to be kept in good condition and show even levels of compression. They should never be allowed to become hardened (reference Figure 5), heavily compressed or perished. In an effort to minimise repair costs, it may be the case that only small parts of a length of hatch rubber are replaced when damaged. This should always be avoided as small repaired areas may lead to uneven compression and gaps in the rubber through which water could pass easily (reference figure 6).
