# The Shipowners' Club Loss Prevention

Fishing vessel safety

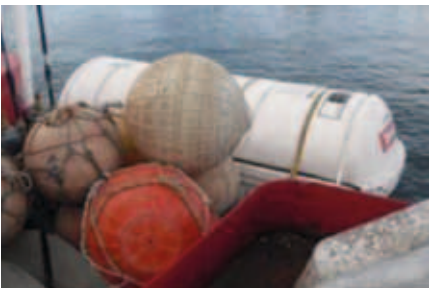
Figure 1: Obstructed life raft

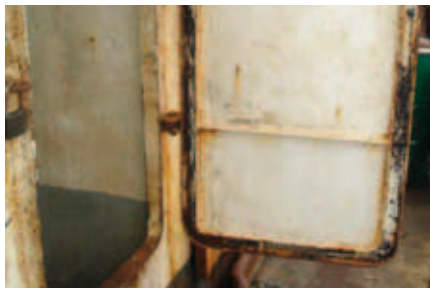
Figure 2: Poorly maintained access rubbers

- **Items to ensure watertight integrity** - It is essential that all openings to the sea have the ability to be made watertight to ensure water does not ingress during normal operations, when transiting or in an emergency. These items include hatches, doors and vents. During maintenance, rubbers must be checked for deterioration and all closing devices must be in place with the ability to close fully. During the Club's routine P&I Condition Surveys on fishing vessels, the poor maintenance of watertight openings is often noted (*Figure 2*)

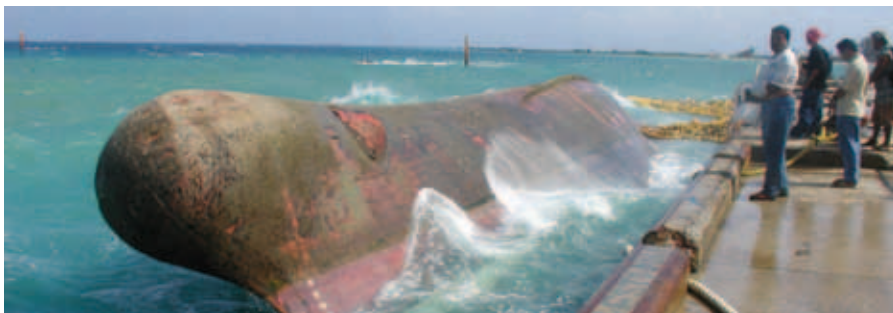
Figure 3: Capsized fishing boat

Other reasons for a vessel to capsize include:

- Free surface effect caused by flooding, therefore reducing stability
- Free water on deck
- Ice accumulation in freezing conditions on the vessel's steelwork and fishing equipment, including pots
- Incorrect stowage of fish
- Lifting weights by derrick, therefore changing the vessel's centre of gravity
- Movement of cargoes
- Openings such as hatches and doors are not watertight or have been left open.

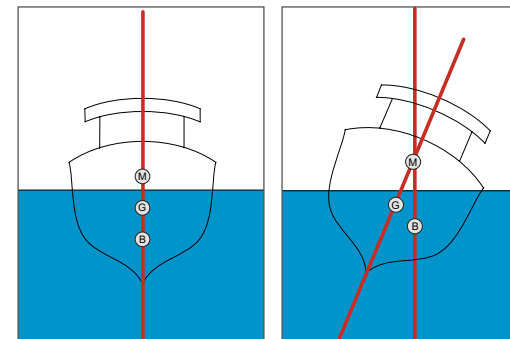
Figure 4: Diagrams to illustrate Centre of Gravity and Buoyancy, Metacentric height and Metacentre

- Centre of Gravity (G) is the point at which all the mass of body may be considered to be concentrated
- Centre of Buoyancy (B) is at the centre of gravity of the underwater volume
- Metacentric height (GM) is the distance between the centre of gravity of a ship and its Metacentre (M). The point on the centre-line of a vessel through which all the forces of buoyancy pass when the vessel is heeled.

All skippers should be aware of their vessel's stability characteristics, how to calculate the prevailing stability condition and the basic terminology used as follows (see Figure 4):

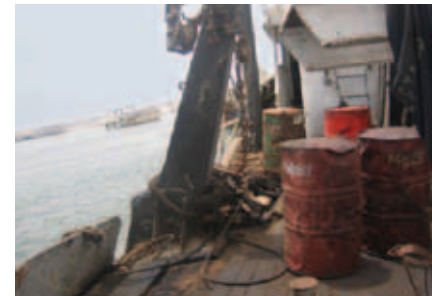
Figure 5: Working deck with many obstructions and dangers

The vessel's working areas should be well lit and, so far as possible, free from any obstructions or potential dangers (Figure 5). Crew members' awareness of lines under tension and snags on the lines or visible bights is vital.

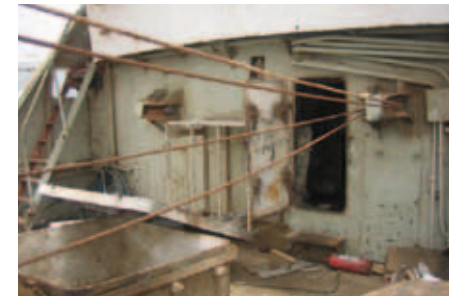
Figure 6: Poorly maintained fire extinguisher not in correct location

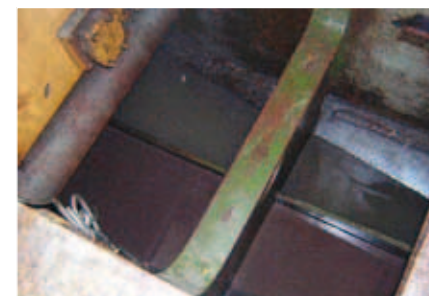
Figure 9: Bilges containing water

- Bilge alarm systems electrical supply is checked and all debris removed. A check should be undertaken at the start of a voyage and then weekly (Figure 9)

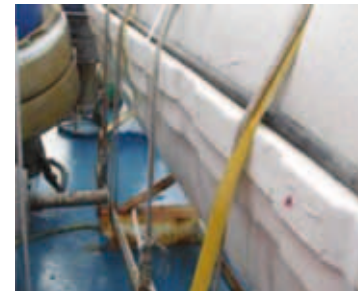
Figure 10: Incorrectly stowed life raft

- Survival craft (weekly) - attention should be paid to ensure the correct installation of the Hydrostatic Release Unit. *Figure 10* illustrates an incorrectly stowed life raft (without a Hydrostatic Release Unit), *Figure 11* illustrates correct stowage
- Alarm signals (weekly)
- Life saving equipment including fire extinguishers (at least every four weeks).

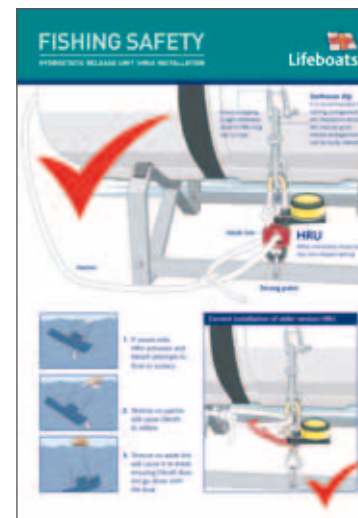
Figure 11: RNLI poster on Hydrostatic Release Units (HRU)

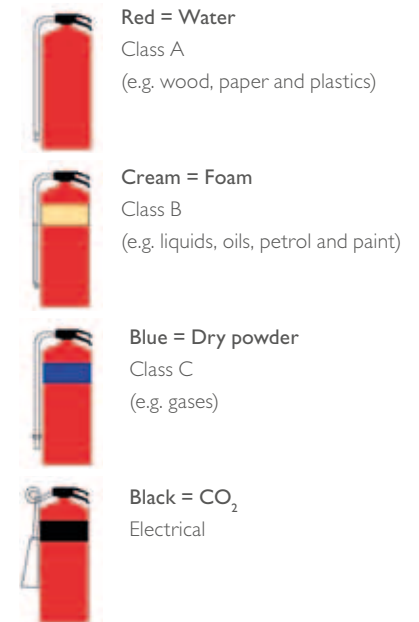
It is important that extinguishers are fit for purpose. Extinguishers are colour coded according to the type of fire they are suitable for and it is essential that crew members are given training on the categories as below:

It is important to select the correct extinguisher!

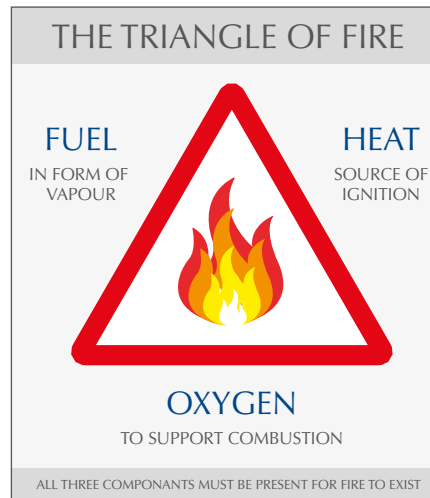
Figure 12: The Triangle of Fire

- The principles of fire fighting, including The Triangle of Fire (Figure 12)
- How to use basic firefighting equipment (including fire blankets)
- The areas most likely to be susceptible to fire hazards e.g. engine room, galley, accommodation spaces, store rooms and wheelhouse
- Fire hazards, by way of oily rags, grease on electrical equipment, cookers and hot surfaces, drying clothes over heaters, stoves and smoking in bunks.

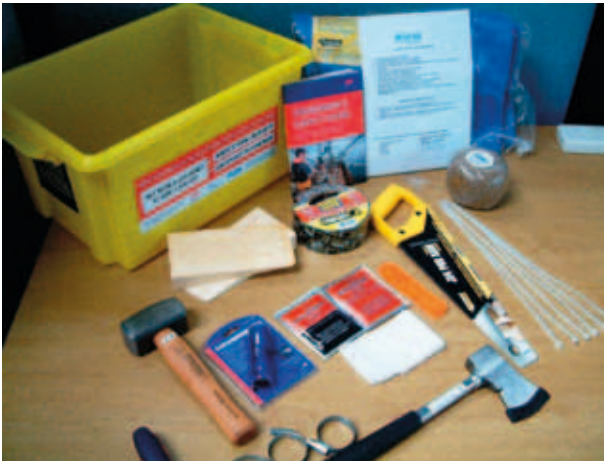
Figure 13: Typical Damage Control Kit

Suggested items to include in a Damage Control Kit are:

- Amalgamating or duct tape
- Assorted pieces of timber (sheet and 0.6m x 0.6m shoring)
- Clamps - jubilee and hose clips (preferably stainless steel) in assorted sizes
- Epoxy resin stick
- Flashlight(s)
- Gland and seam packing material
- Hammer
- Hatchet and/or axe
- Heavy twine
- Knife with a serrated edge
- Saws (wood and hack saws)
- Screwdrivers
- Softwood plugs (assorted sizes)
- Spare hose lengths to fit pipes in use on board
- Tarpaulin (1.8m x 1.8m with eyelets at each corner)
- Wooden wedges
- Wrapping material (e.g. rubber sheet).

Many incidents and vessel losses are the results of flooding. Fishermen are taught little about preventing their vessels from sinking once water ingress begins. Preventing this from happening could be achieved through thorough and regular maintenance, but saving the vessel during a flooding incident could be achieved by having knowledge of damage control and the right equipment on board (i.e. Damage Control Kit - *Figure 13*).
