## ► CASE STUDY

### Carbon monoxide poisoning results in fatalities

**This case study has been extracted from the MAIB Safety Bulletin 2/2016 & the MAIB Accident Report no 9/2017.**

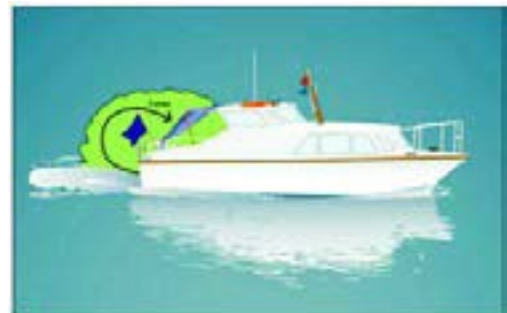
The motor cruiser's 5.7 litre petrol-driven inboard engine had been left running at 3000rpm while it was moored alongside, mostly likely to charge the batteries. A slight wind blowing from the stern caused exhaust gas, emitting from below the aft transom, to enter the canopy covering the aft deck from where it spread down into the accommodation area forward.

- occupants of vessels without carbon monoxide (CO) alarms will have no warning if the lethal fumes are present in habitable areas. It is essential that CO sensors are fitted in areas where CO could accumulate and pose a risk to health (such as the accommodation areas).
- the use of canopies can lead to the accumulation of CO within an enclosed space and potentially increase the risk of poisoning, even when a boat is making way. It must be ensured that all spaces, including those under a canopy or an awning are always well ventilated.
- CO is a silent killer and it is important to recognise that the symptoms can be similar to colds, flu or hangovers - headaches,
