## Guidance On Ensuring The Weathertight Integrity of Hatch Covers

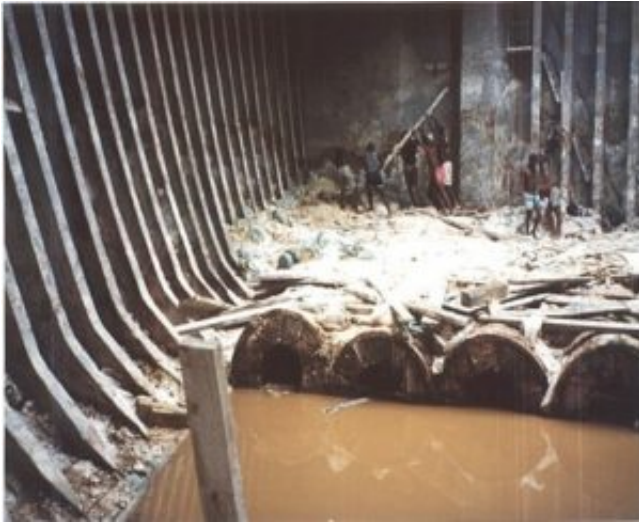
Figure 1: Cargo damage due to water ingress

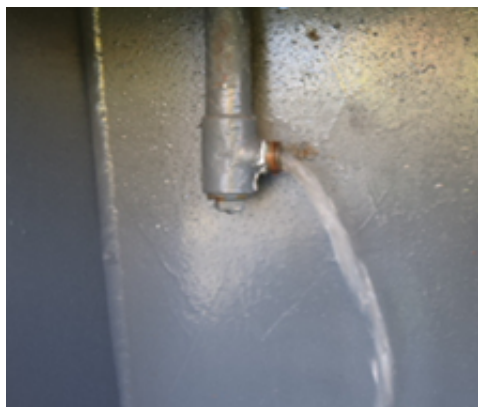
Figure 4: Non-return valve not fitted to the drainage arrangement

It is also essential that this drainage system does not become blocked as if it does, the water has no path to drain into and may spill over into the cargo hold, damaging the cargo (reference Figure 3). The water in this drainage channel should pass through a non-return valve installed at the end point and not through an open pipe or section of fire hose. It must be noted that if a non-return valve is not fitted, heavy seas can flow in the opposite direction, into the cargo hold (reference figure 4). These non-return valves should be removable or enable easy access for cleaning to prevent blockage of drainage pipes.

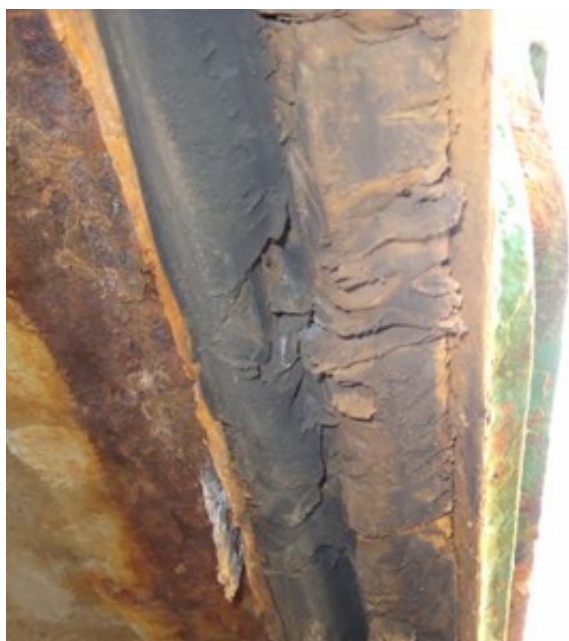
Figure 5: Hardened indented rubber seals

Hatch cover rubber seals need to be kept in good condition and show even levels of compression. They should never be allowed to become hardened (reference Figure 5), heavily compressed or perished. In an effort to minimise repair costs, it may be the case that only small parts of a length of hatch rubber are replaced when damaged. This should always be avoided as small repaired areas may lead to uneven compression and gaps in the rubber through which water could pass easily (reference figure 6).

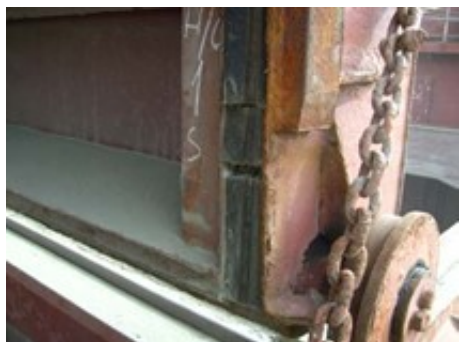
Figure 6: Section replacement of rubber seal
