## Guidance On Ensuring The Weathertight Integrity of Hatch Covers

The Club in collaboration with [Van Ameyde McAuslands](#) has produced this advice on effective hatch cover maintenance for dry cargo ships including preventative action against ingress of water. Van Ameyde McAuslands have been providing advice and support to the marine industry since 1888. Founded in Hull, UK, the surveying team have a combined seagoing and surveying experience of over 400 years. In April 2019 they became a member of the Van Ameyde Group, further strengthening their depth of expertise and reach. The Club would like to thank Van Ameyde McAuslands for their invaluable assistance in producing this advice.

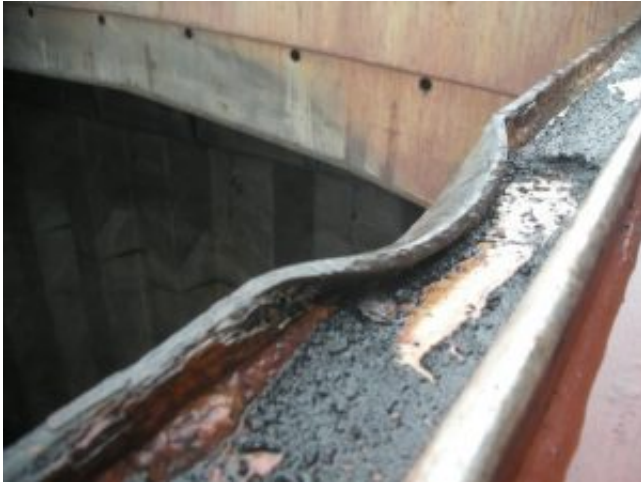
Figure 2: Damaged cargo hatch sill

As demonstrated in Figure 2, damage or warping to the inner sill can be caused by contact with the cargo itself or cargo gear such as grabs, chutes or chains. In these cases it is strongly recommended that permanent repairs are carried out as soon as possible. While the hatch cover seals themselves may be well maintained, if other parts of the hatch cover sealing arrangement are in poor working condition or compromised, cargo wetting could occur, resulting in exposure to high quantum claims.

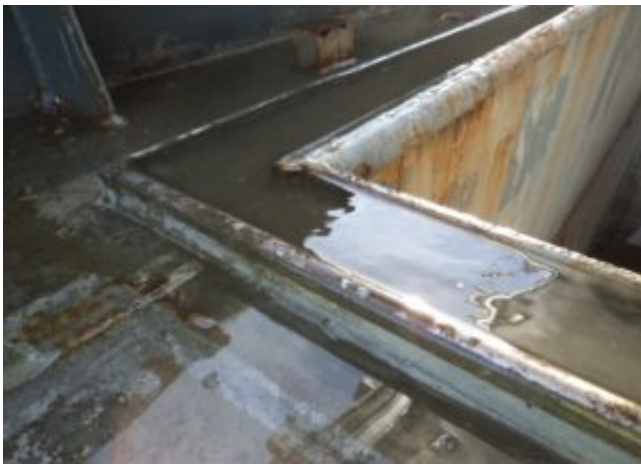
Figure 3: Overflowing drainage channels

It is also essential that this drainage system does not become blocked as if it does, the water has no path to drain into and may spill over into the cargo hold, damaging the cargo (reference Figure 3). The water in this drainage channel should pass through a non-return valve installed at the end point and not through an open pipe or section of fire hose. It must be noted that if a non-return valve is not fitted, heavy seas can flow in the opposite direction, into the cargo hold (reference figure 4). These non-return valves should be removable or enable easy access for cleaning to prevent blockage of drainage pipes.

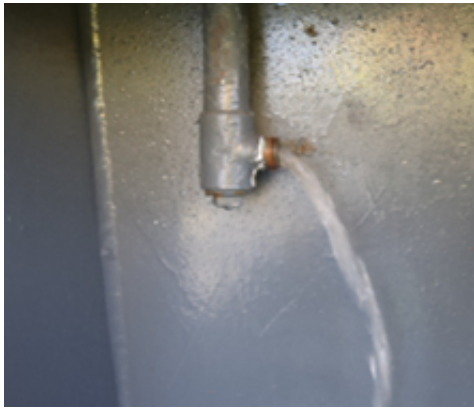
Figure 4: Non-return valve not fitted to the drainage arrangement

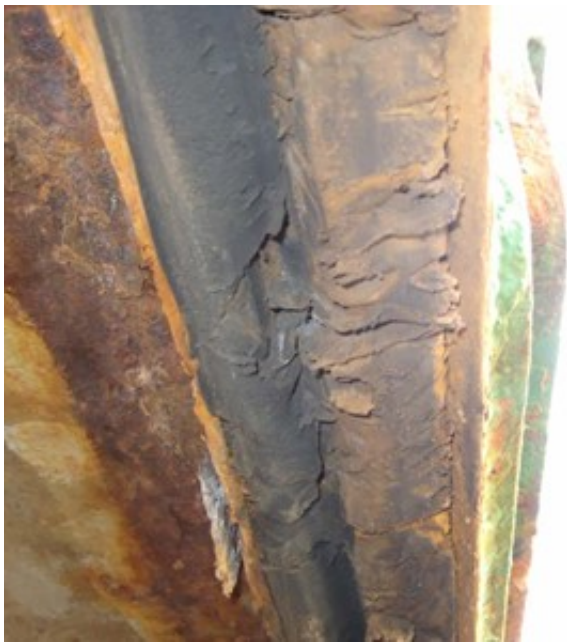
Figure 5: Hardened indented rubber seals

Hatch cover rubber seals need to be kept in good condition and show even levels of compression. They should never be allowed to become hardened (reference Figure 5), heavily compressed or perished. In an effort to minimise repair costs, it may be the case that only small parts of a length of hatch rubber are replaced when damaged. This should always be avoided as small repaired areas may lead to uneven compression and gaps in the rubber through which water could pass easily (reference figure 6).
