► **LOSS PREVENTION**

Learning from Passenger  
Vessel Incidents

**SHIPOWNERS**

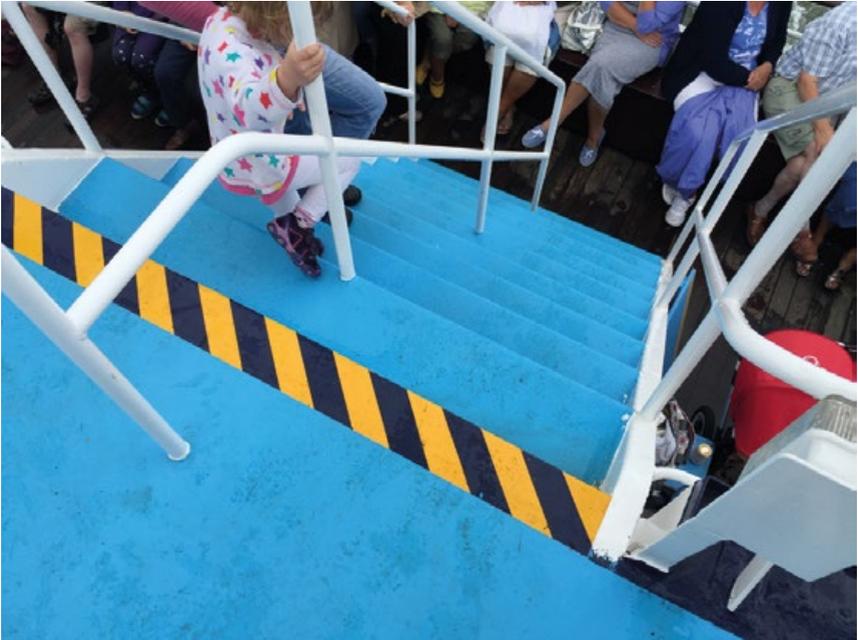
Tripping hazards have also been identified as a frequent cause of claims and over a two-year period the Club has paid US\$ 3,688,052 as a result. Areas that have been most hazardous in this respect are the tops and bottoms of stairways, door sills or abrupt changes in deck level. One of the most effective methods of dealing with these hazards, in the Club's experience, is to use colour to emphasise the change in level.

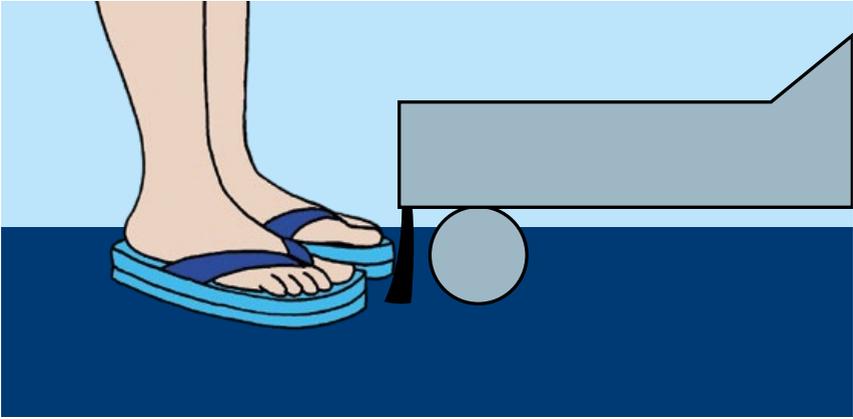
To mitigate the re-occurrence of such incidents, one suggested measure is the fitting of brushes/rubber to the bottom edge on the gangway. This attachment would allow the passenger to notice the possible movement by touch on their feet before any injury is sustained, such as that shown in the following image.

One common cause of personal injury incidents that the Club has been exposed to is when the gangway between the ship and shore has surged on the quayside due to the prevailing waves or a third party vessel's wash as it passes by. This risk is highlighted in Annex 2, Case Study 2.

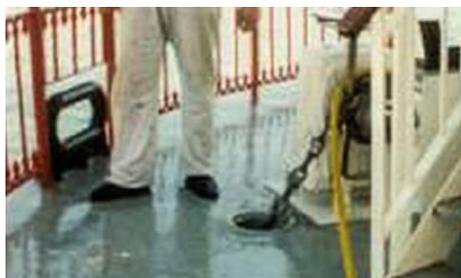
The vessel in question is a Mississippi showboat steamer that carried out harbour cruises where passengers could enjoy meals and cabaret type entertainment. Passengers were actively encouraged to walk freely around the open decks, including the fore and aft decks, to enjoy the view as the cruise proceeded.

Situated in the bow area of the vessel was the anchor windlass and an associated hawse pipe which had not been provided with a cover (an oversight from the time the vessel was built), leaving it exposed. It is not clear whether the fall was caused by the passenger stepping into the open pipe or by catching her walking stick on it as she passed by. However, a contributing factor to this incident was the fact the opening was not covered or fenced off. Another factor was considered to be the inadequate lighting in the area with shadows masking the hazard.

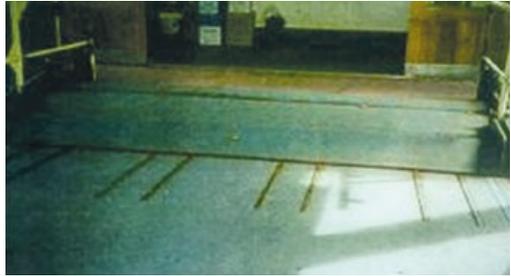
This incident arose on board a harbour ferry operating in smooth water. The harbour ferry was fitted with hydraulic ramps designed for the embarkation and disembarkation of passengers. The ramps had been lowered to enable passengers to board the vessel and having been positioned, hydraulics were 'locked'.

Shortly after passengers started to board, another vessel berthed in an adjacent wharf creating some wake. The combination of the wake and wave actions in the harbour caused the ferry to surge and roll. The movement resulted in the hydraulic ramp fitted to the ferry rising a few inches above the connecting hydraulic ramp fitted to the jetty. When the vessel rolled back a passenger's foot was trapped between the ramps.
