▶ GUIDANCE ON ENSURING THE WEATHERTIGHT INTEGRITY OF HATCH COVERS

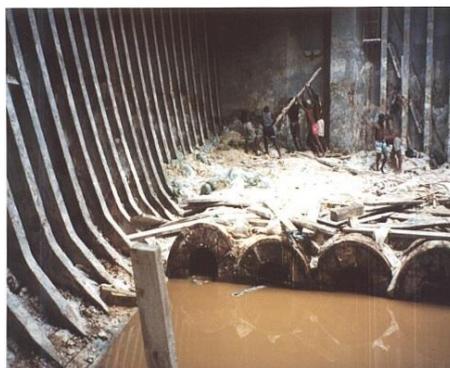
Figure 1: Cargo damage due to water ingress

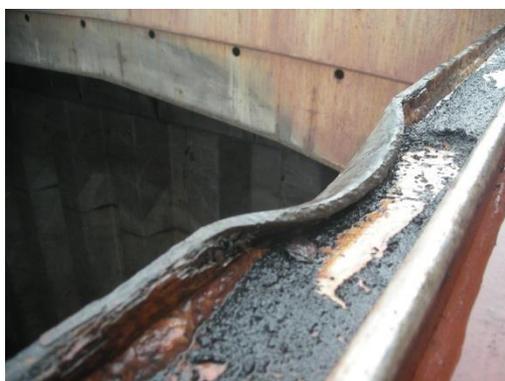
Figure 2: Damaged cargo hatch sill

As demonstrated in Figure 2, damage or warping to the inner sill can be caused by contact with the cargo itself or cargo gear such as grabs, chutes or chains. In these cases it is strongly recommended that permanent repairs are carried out as soon as possible. While the hatch cover seals themselves may be well maintained, if other parts of the hatch cover sealing arrangement are in poor working condition or compromised, cargo wetting could occur, resulting in exposure to high quantum claims.

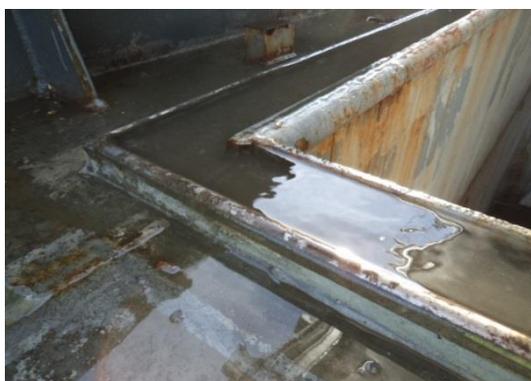
Figure 3: Overflowing drainage channels

It is also essential that this drainage system does not become blocked as if it does, the water has no path to drain into and may spill over into the cargo hold, damaging the cargo (reference Figure 3). The water in this drainage channel should pass through a non-return valve installed at the end point and not through an open pipe or section of fire hose. It must be noted that if a non-return valve is not fitted, heavy seas can flow in the opposite direction, into the cargo hold (reference figure 4). These non-return valves should be removable or enable easy access for cleaning to prevent blockage of drainage pipes.

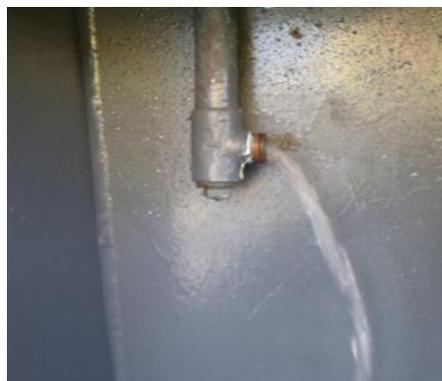
Figure 4: Non-return valve not fitted to the drainage arrangement

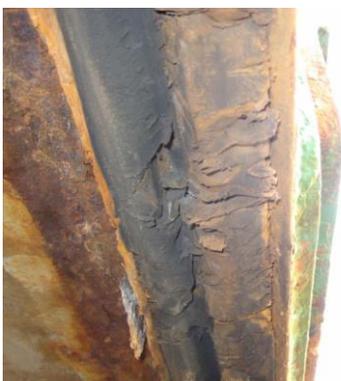
Figure 5: Hardened indented rubber seals

Hatch cover rubber seals need to be kept in good condition and show even levels of compression. They should never be allowed to become hardened (reference Figure 5), heavily compressed or perished. In an effort to minimise repair costs, it may be the case that only small parts of a length of hatch rubber are replaced when damaged. This should always be avoided as small repaired areas may lead to uneven compression and gaps in the rubber through which water could pass easily (reference figure 6).

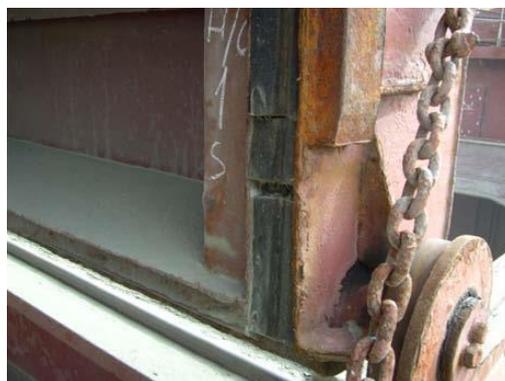
Figure 6: Section replacement of rubber seal
