## CASE STUDY

**VESSEL TYPE:** DRY CARGO  
**TRADING AREA:** ASIA  
**HEADING:** A Cover Up

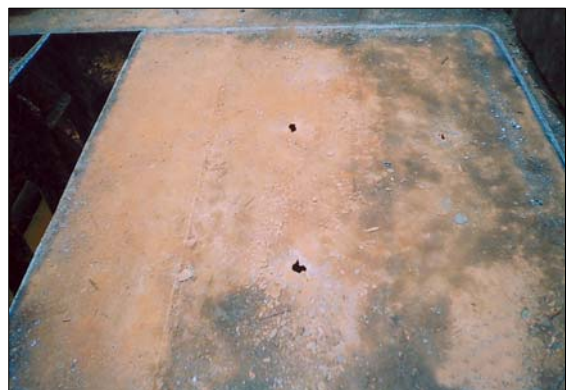
Upon completion of the discharge it was found that the hold contained approximately 30 cm of free water. The tank top was covered by wooden sheathing and, once this had been removed, it became clear the tank top was holed in a number of places. These penetrations into the double tank had allowed ballast water to enter the hold.

available. The tank top had suffered severe corrosion which had been masked by the permanent wooden deck sheathing. This case emphasises the need to ensure that tank tops are examined at regular intervals. Sections of the protective cladding must be removed at this time to facilitate a thorough examination.

We cannot over emphasise the need for the close monitoring of the vessel's stability at all stages of a voyage and the need to retain all relevant calculations.
