► **LOSS PREVENTION**
Refrigeration on Fishing Vessels

SHIPOWNERS

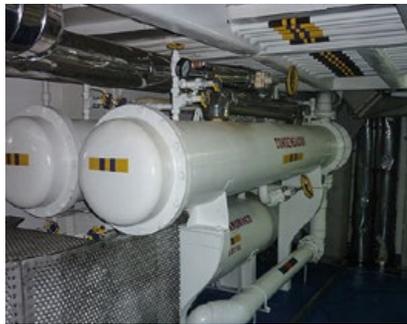
Ammonia receivers with colour coded pipework and protective grating around exposed parts

A good standard of line identification and valve marking, such as colour-coding and/or labelling, will also help in making sure sections of the system are properly isolated during maintenance periods and furthermore will greatly assist when having to isolate a leaking section in an emergency. The ready availability or prominent posting of a system layout diagram will also be beneficial.

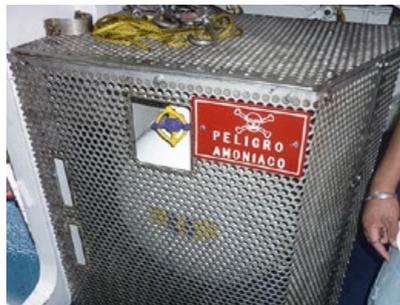
Example of well protected refrigeration equipment/pipework

- Protection: barriers must be fitted to guard equipment and pipework to protect equipment, components and pipes from impact damage.
- Signage: ensure appropriate warnings are conspicuously posted.
- Fishing and/or Cargo Operations: consider how the routine working operations could affect the safety of the plant and how the positioning of the plant could affect safe working.

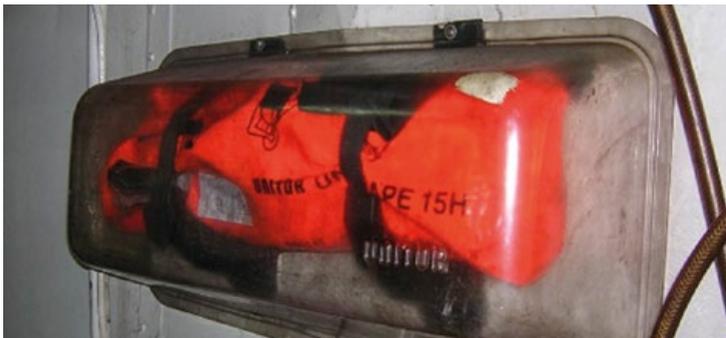
EEBD in Situ

In addition to any mandatory requirements on carrying SCBA units that may apply, consideration should be given to the use of emergency escape breathing devices (EEBDs) – the quick and easy deployment of which will allow a crew member to escape safely from an affected area. Crew would be trained in their use and the devices conspicuously placed (with prominent signage). As with SCBA units they should be periodically checked to ensure they remain fully charged and in full working order. It should be stressed that EEBDs are for use in the event of an escape and not suitable as a breathing apparatus for re-entry into an affected space.
